Concrete Growth and Fatigue Analysis of Chickamauga Lock Miter Gate Anchorages

Final report

Under Project 111274, "Structural Analysis of Chickamauga Lock Gate Anchor Rods"

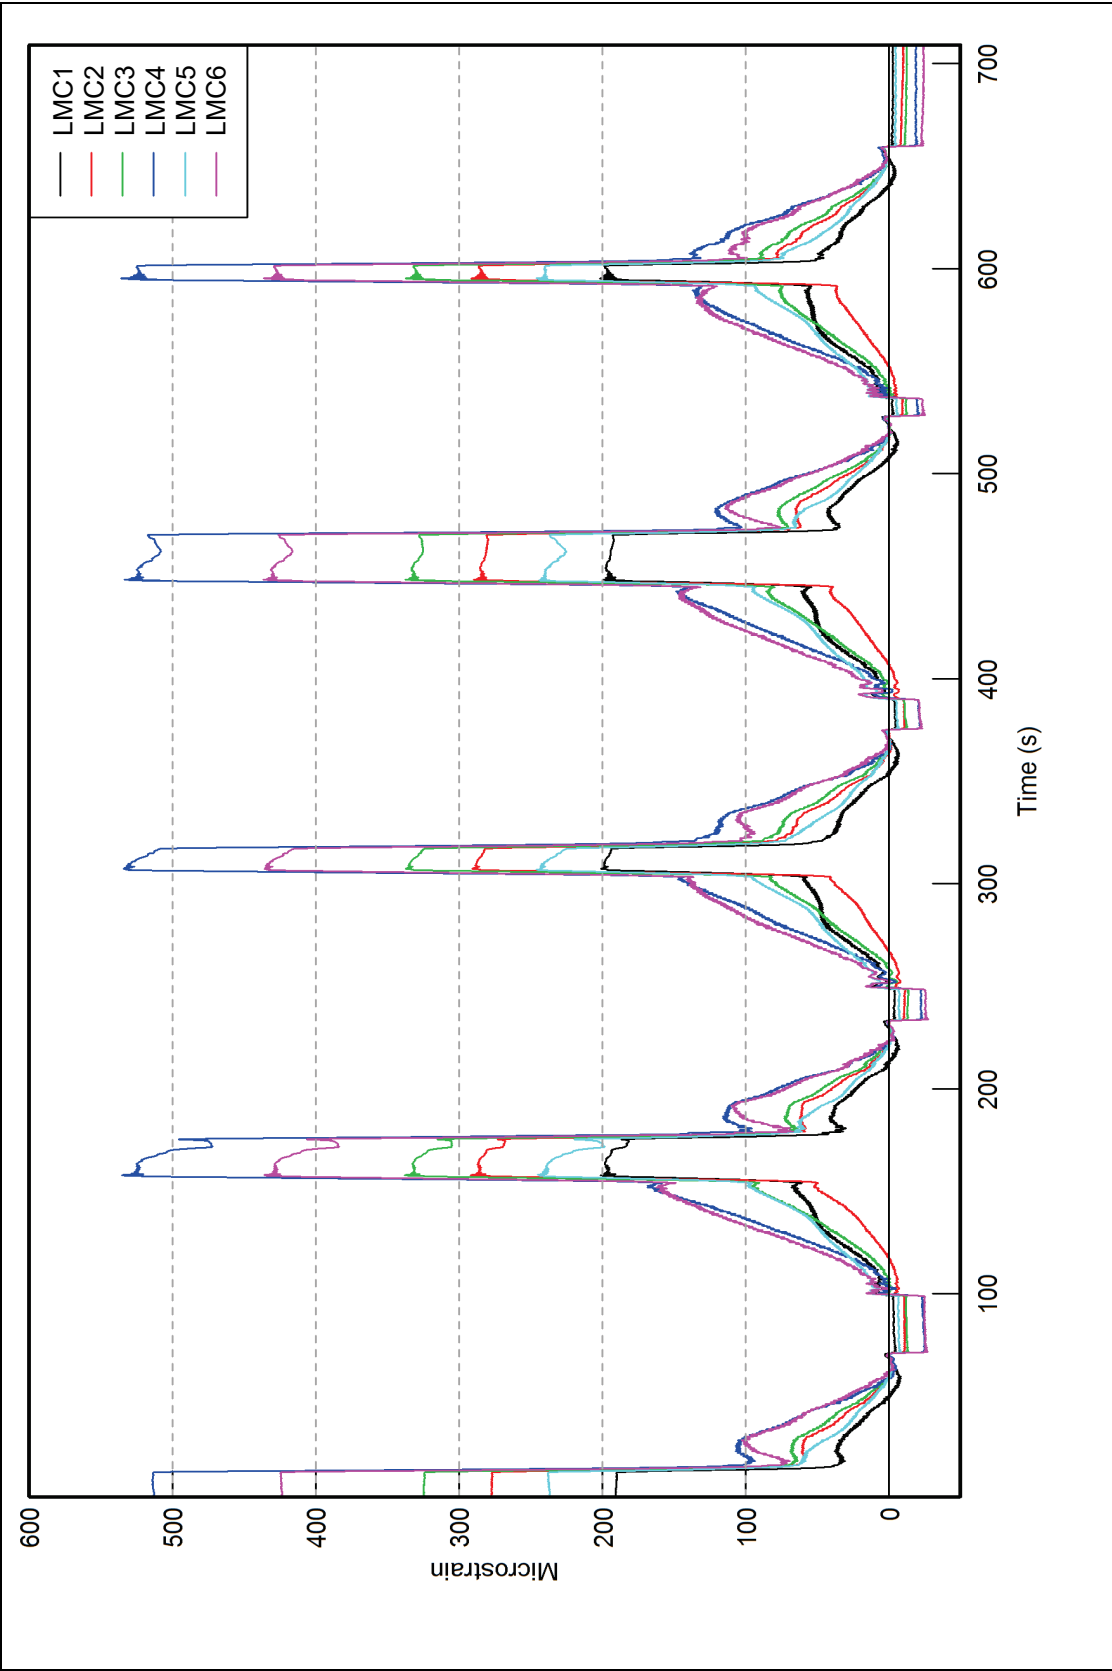
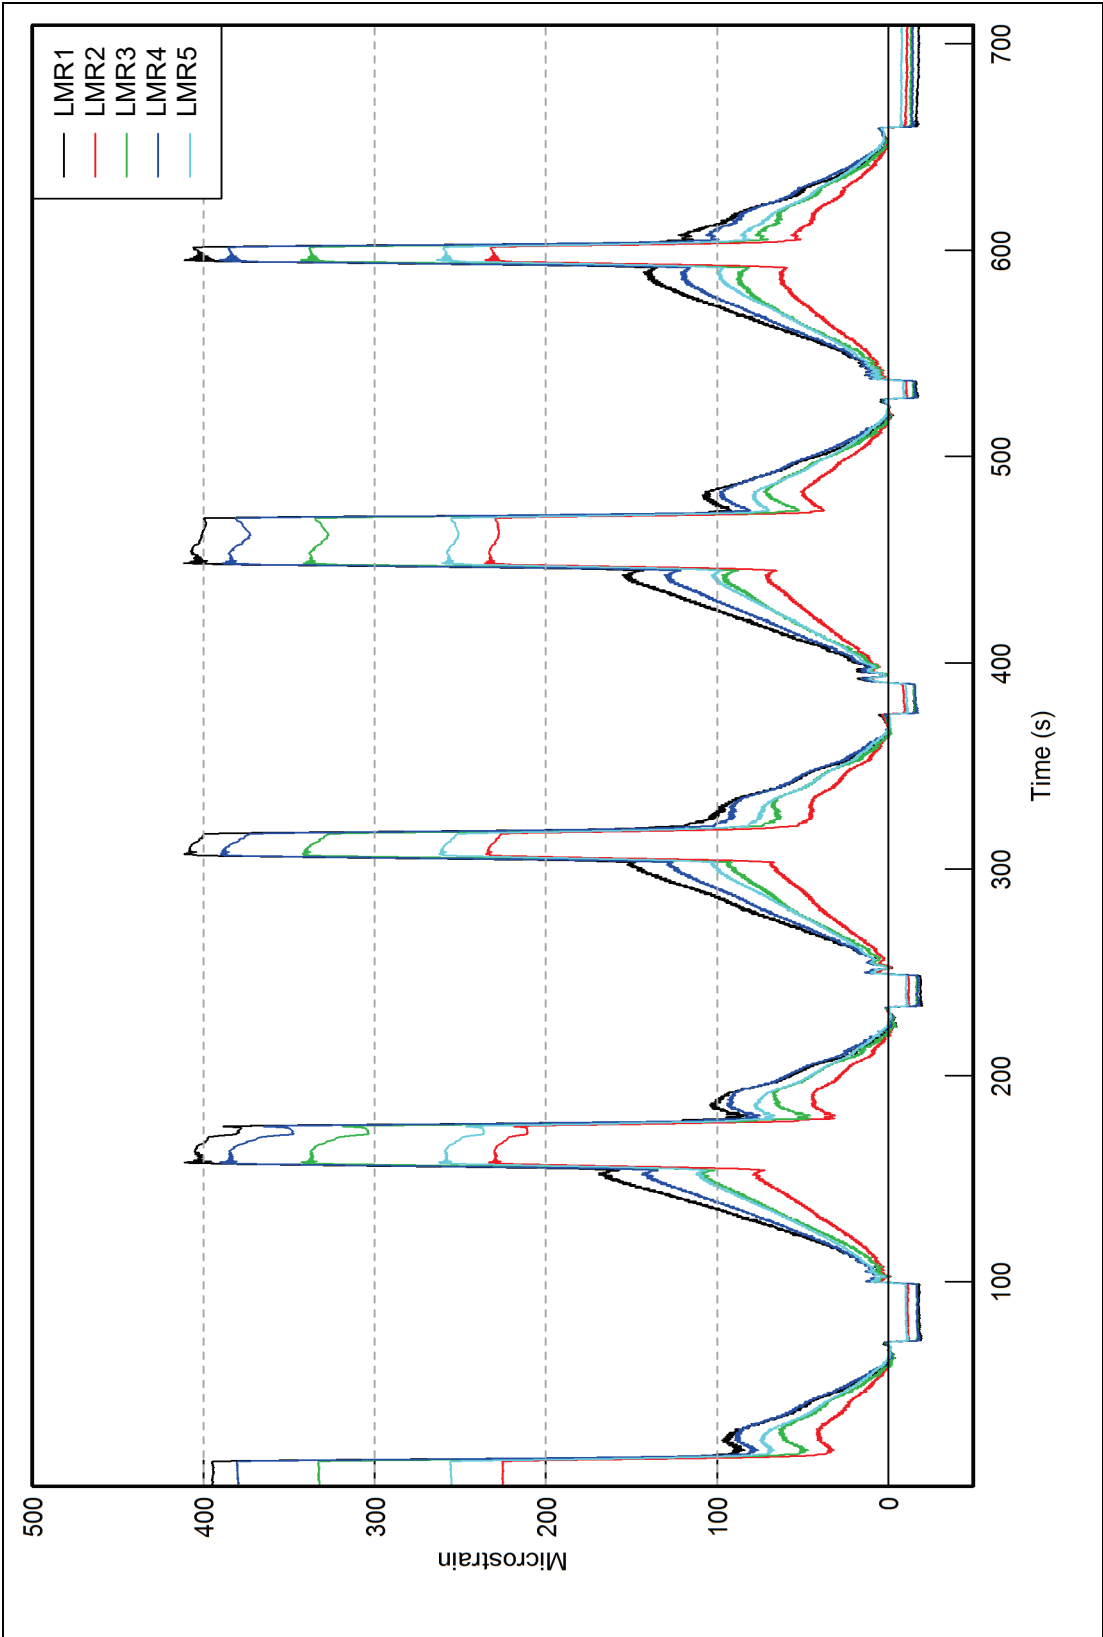
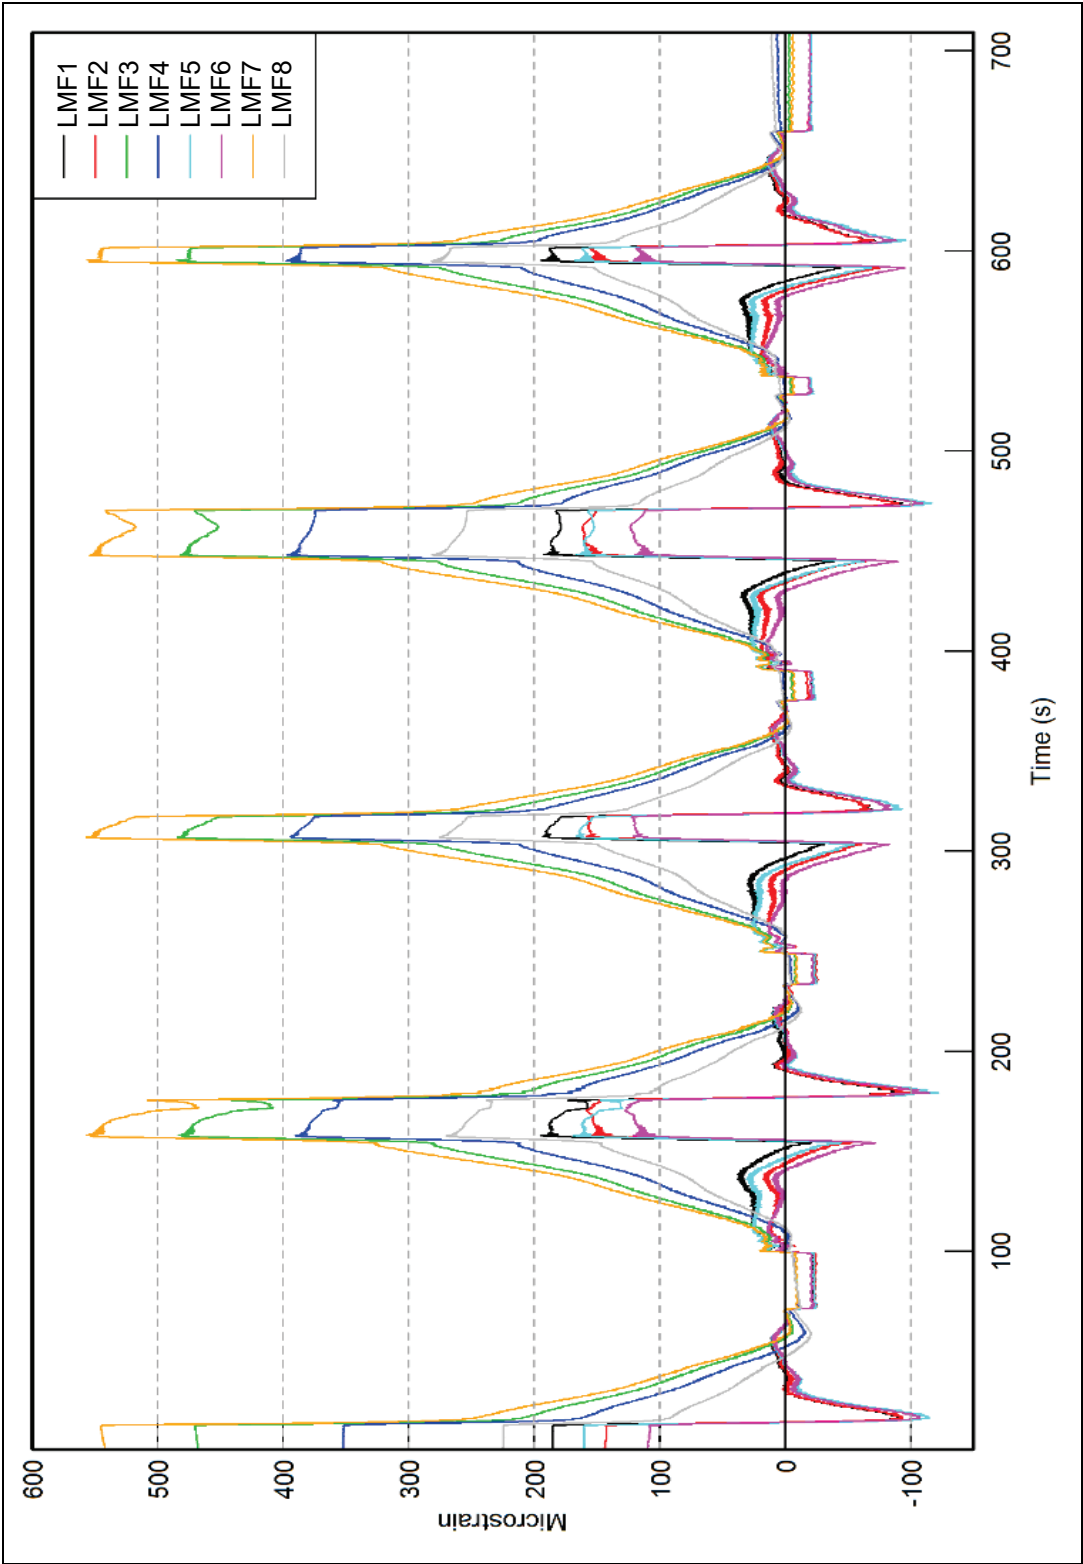
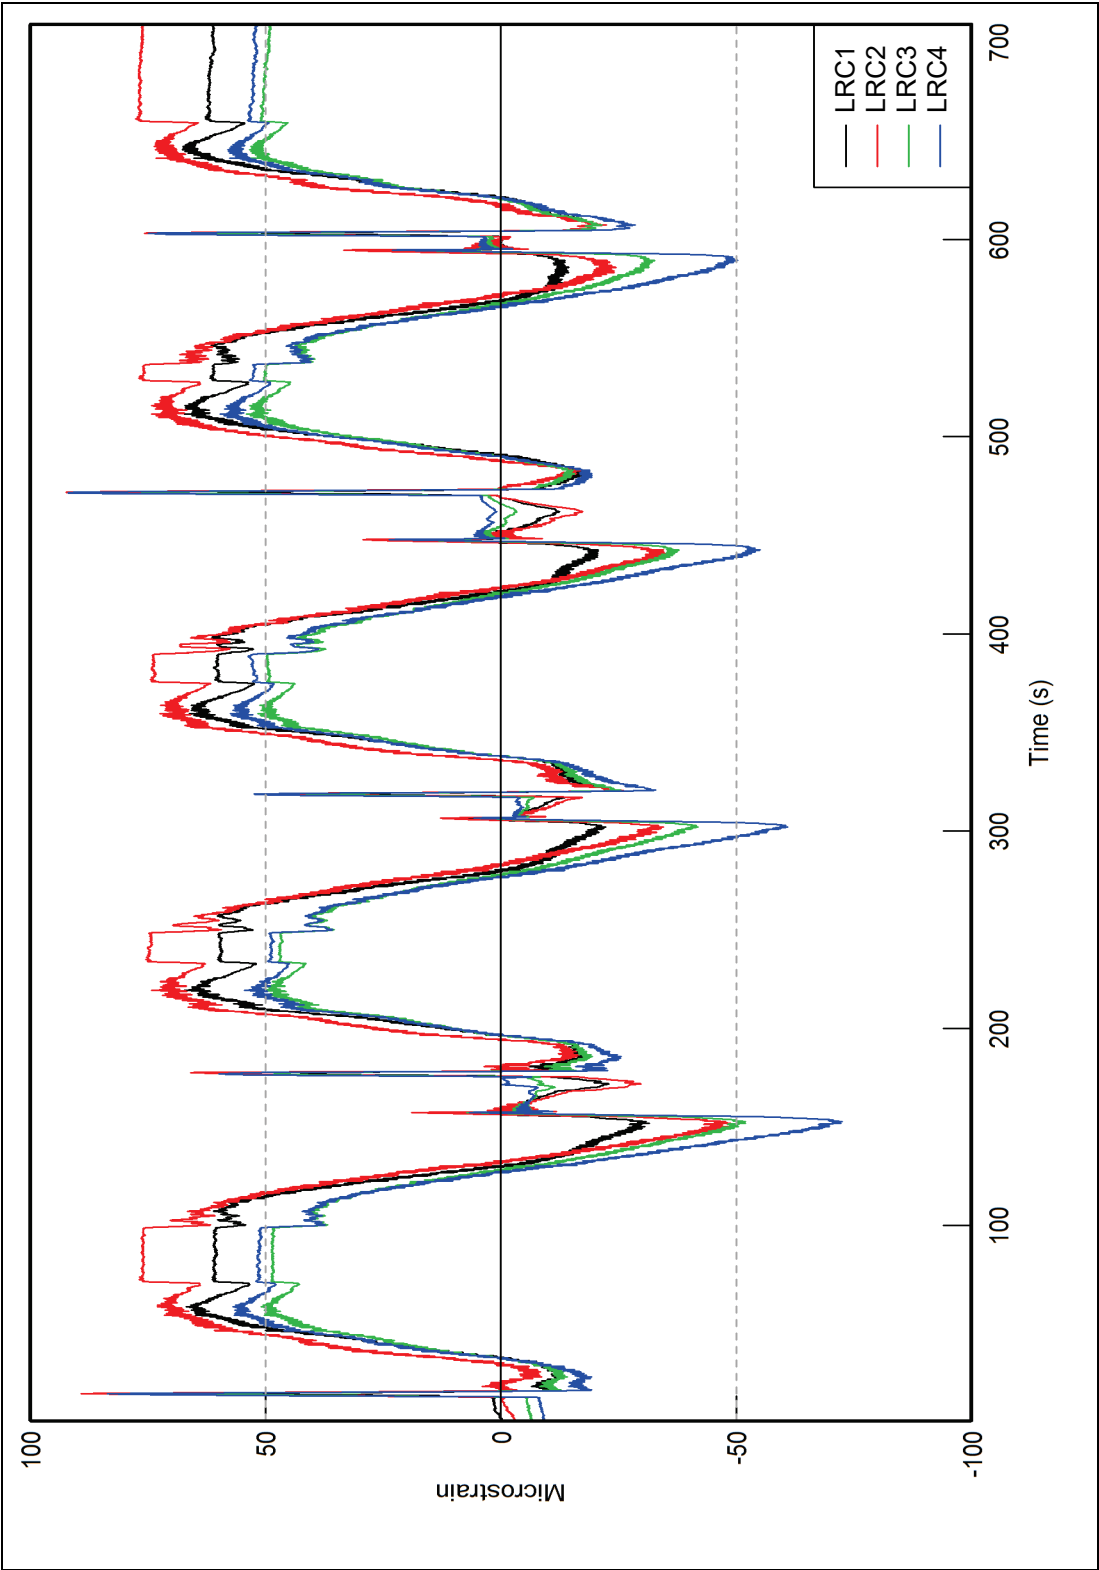
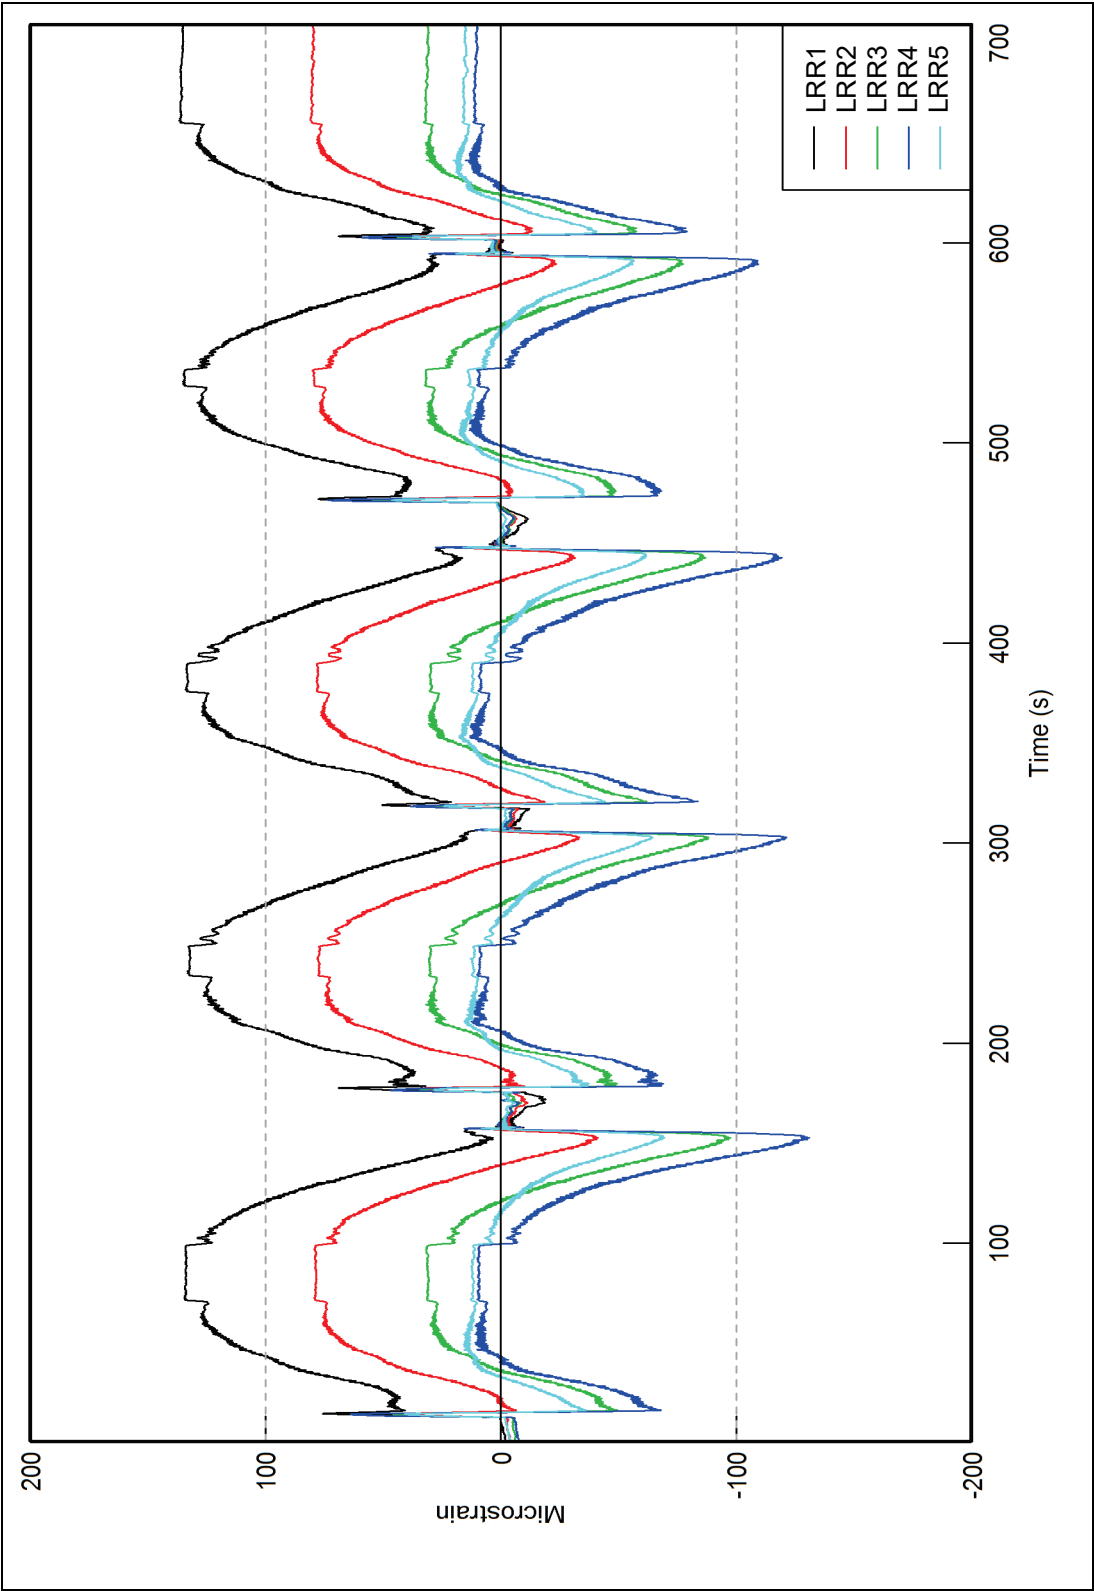
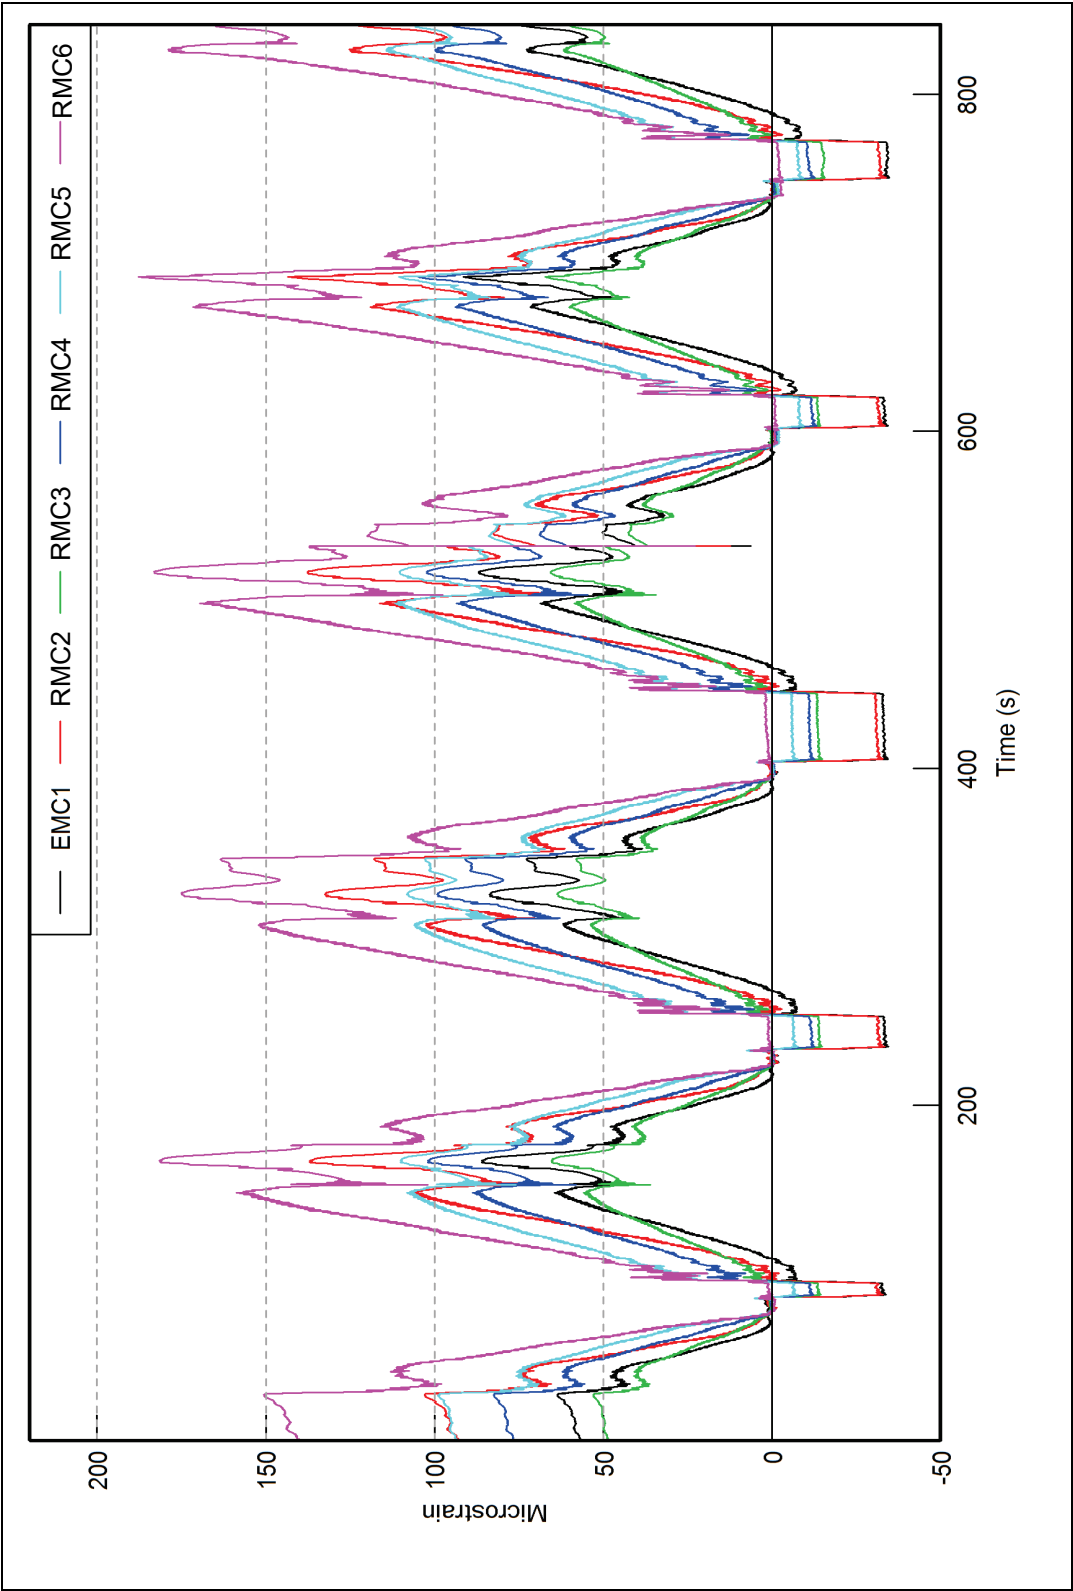
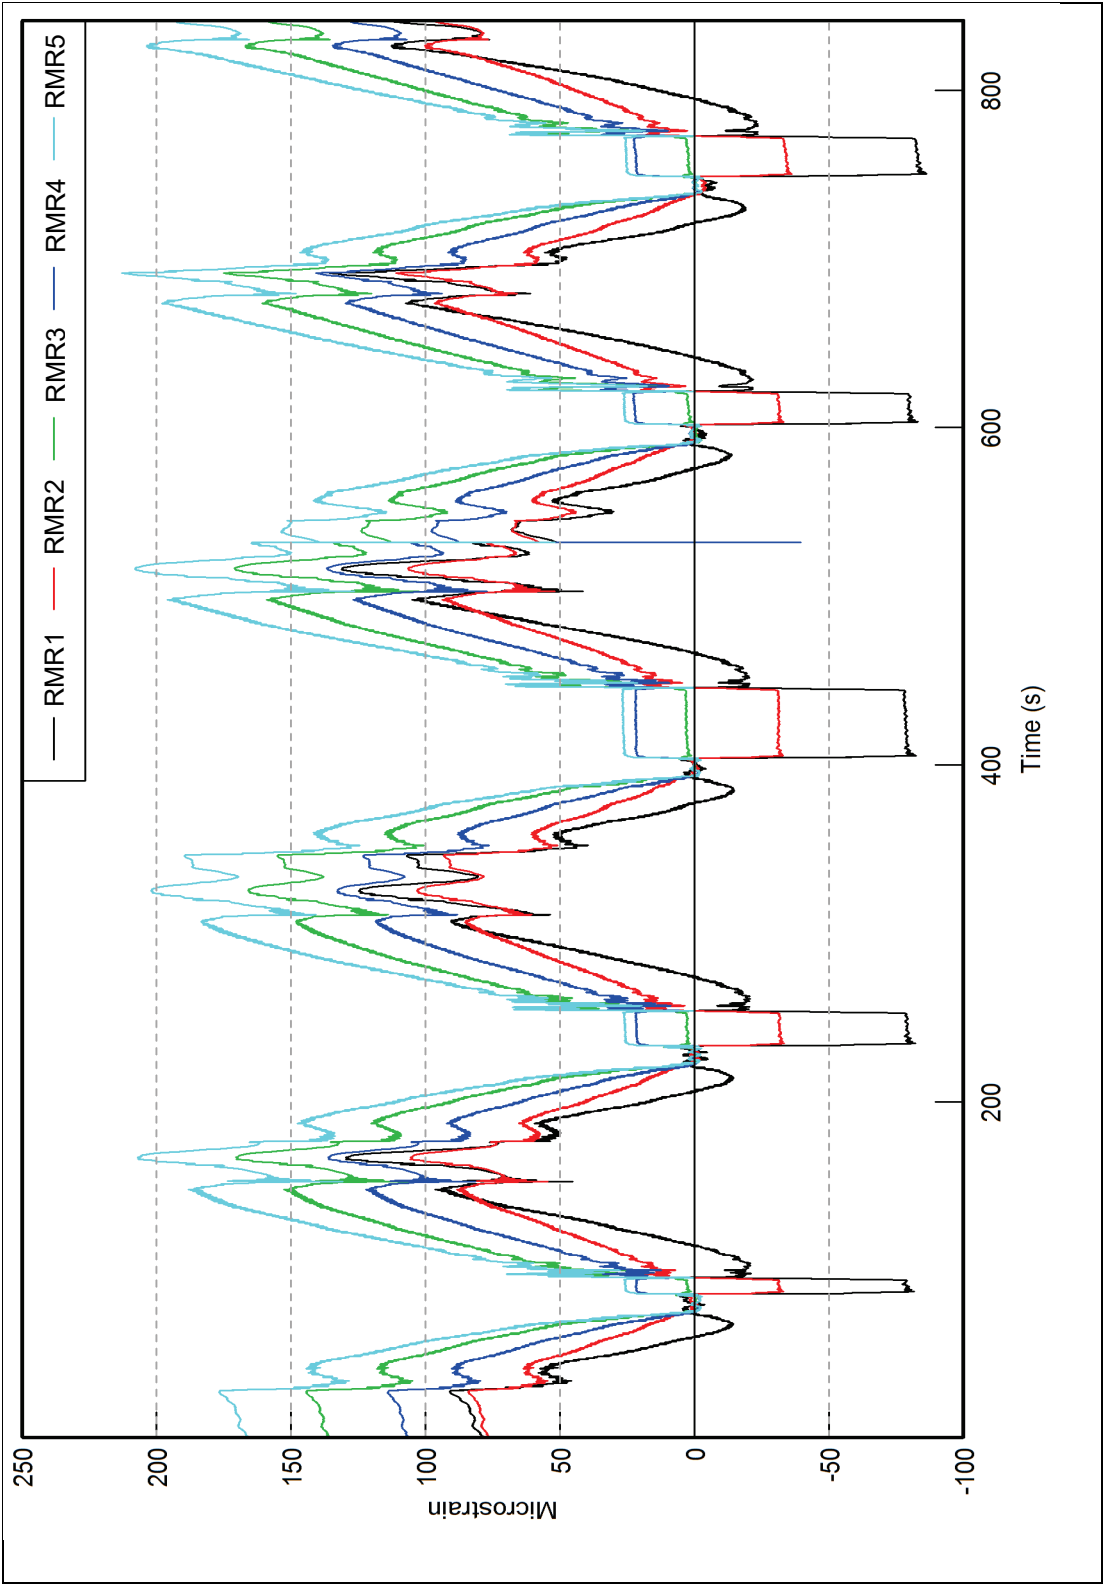
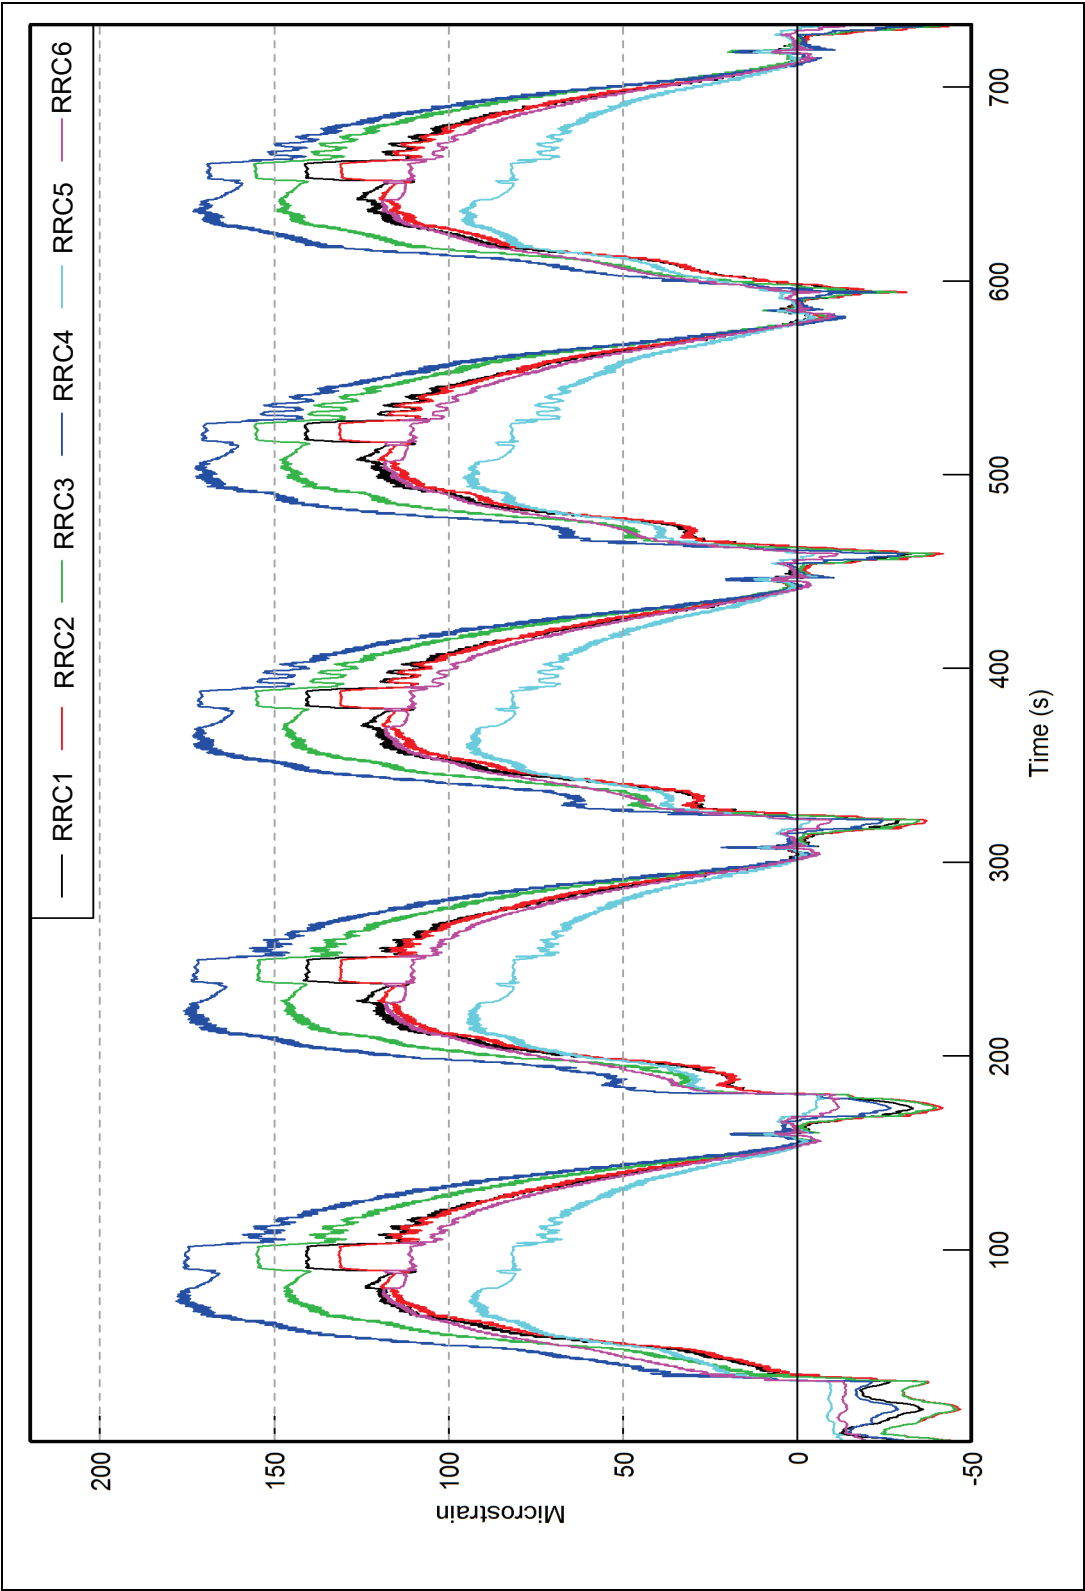
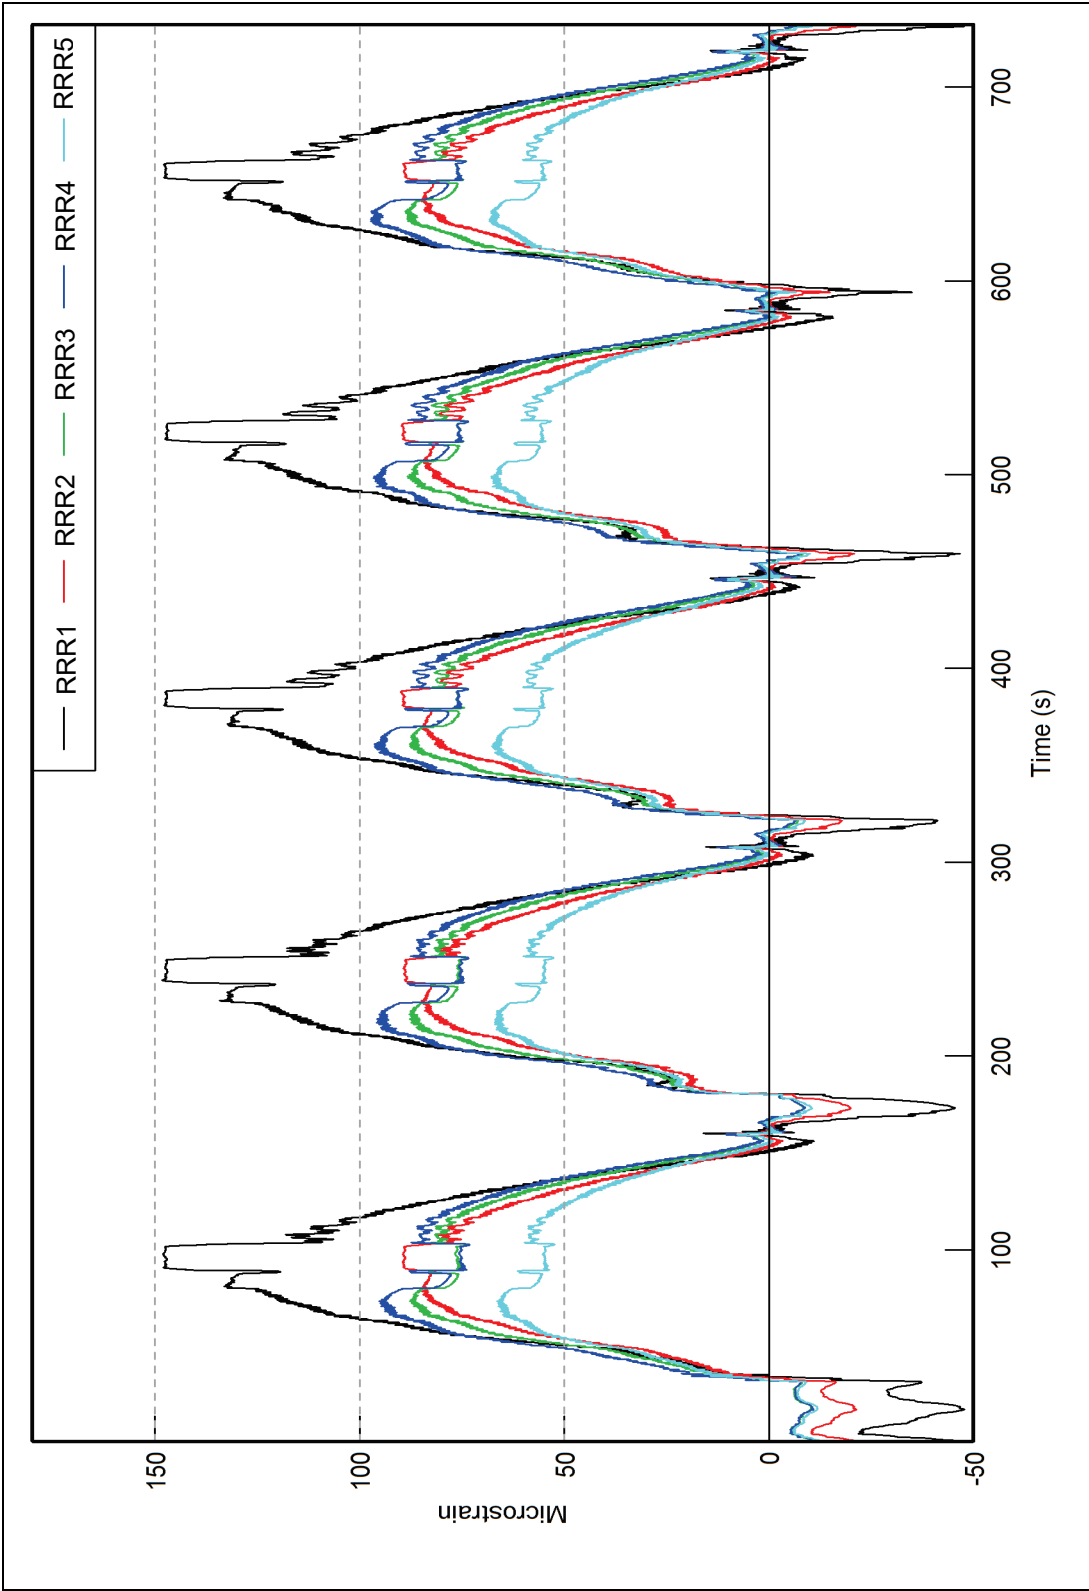
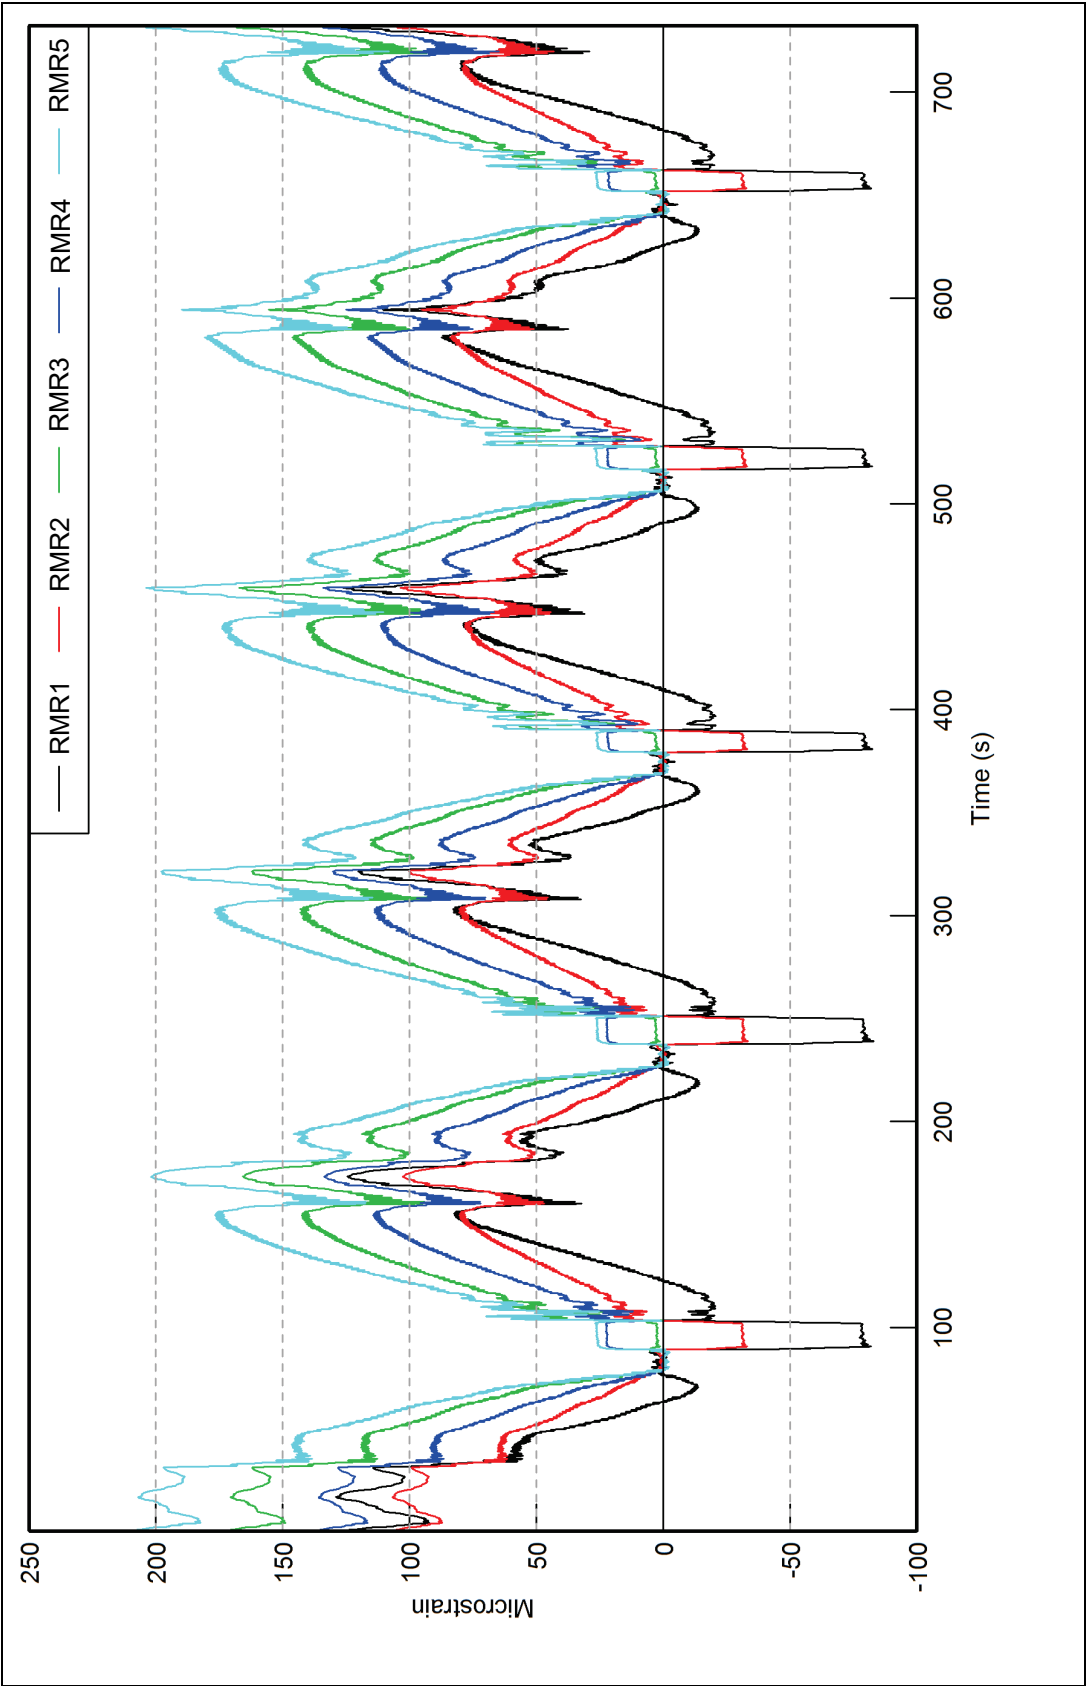
The gage records were analyzed to determine when the gates were in recess but not being compressed into the wall. This gate position was used to determine the no-stress condition of the gages on the miter anchorage (xMx gages). The gage records were also analyzed to determine when the gates had just come into contact at the miter blocks but the gates had not yet been compressed together. This gate position was used to determine the no-stress condition of the gages on the recess anchorages (xRx gages). These points were used to set the “zero” value for the gage records, and the gage plots shown already include this offset. The strain measurements are shown in Figure 19 through Figure 30.

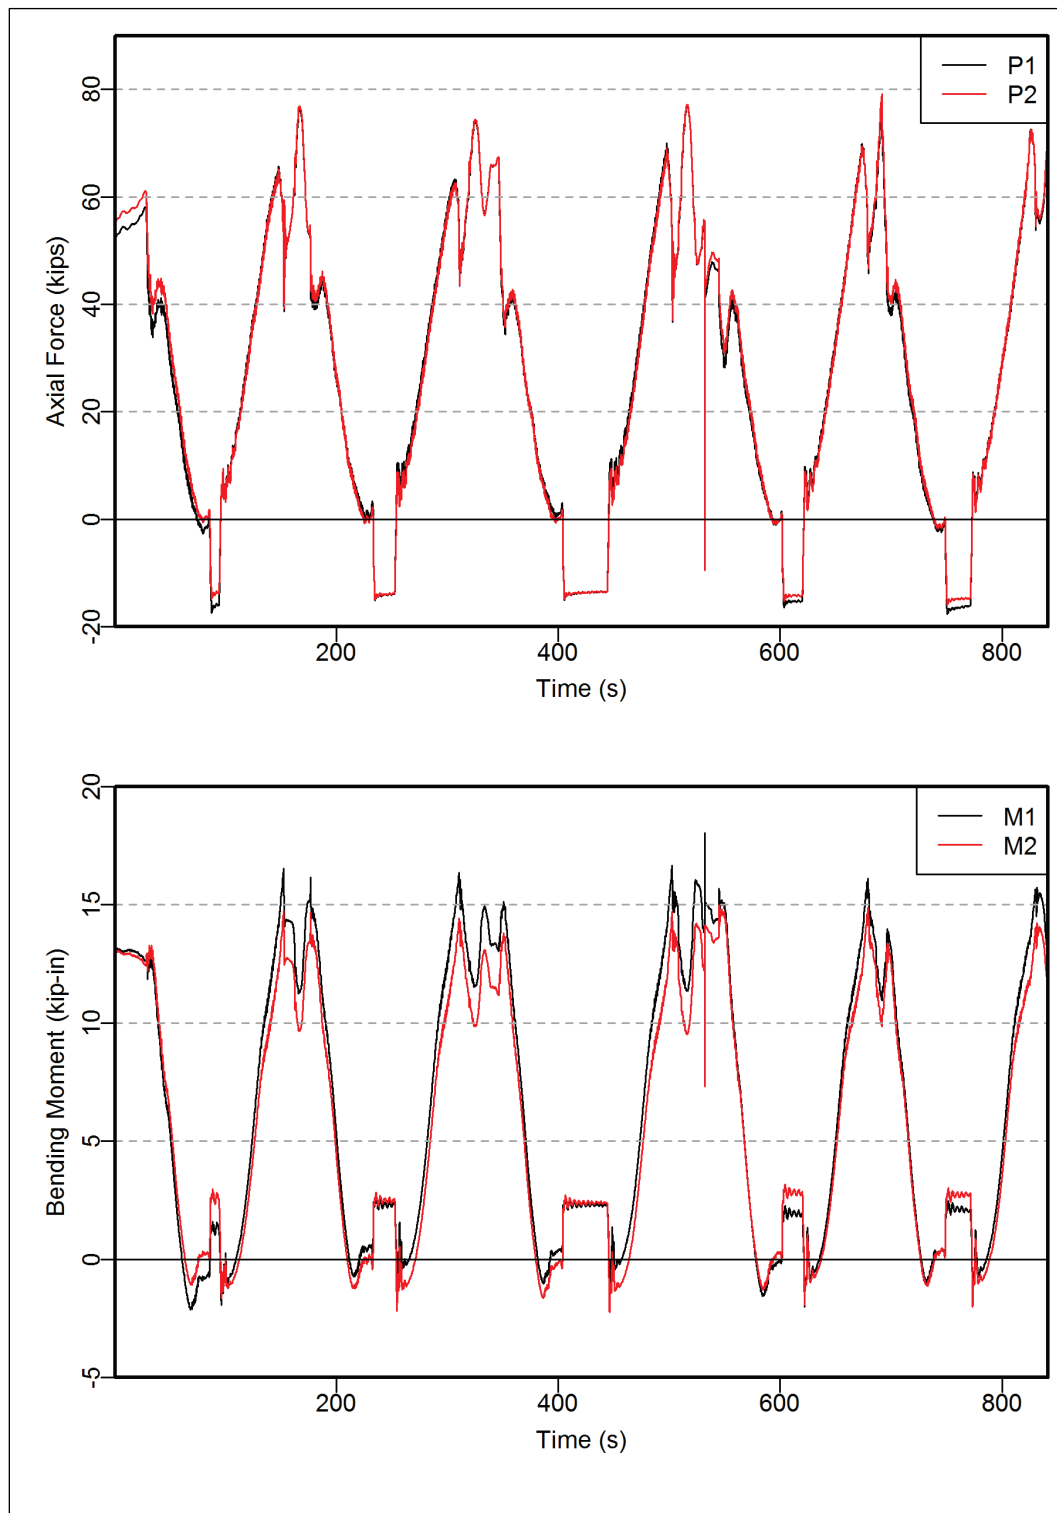
Figure 32. Computed forces in riverside miter rectangular segment – Set 2.

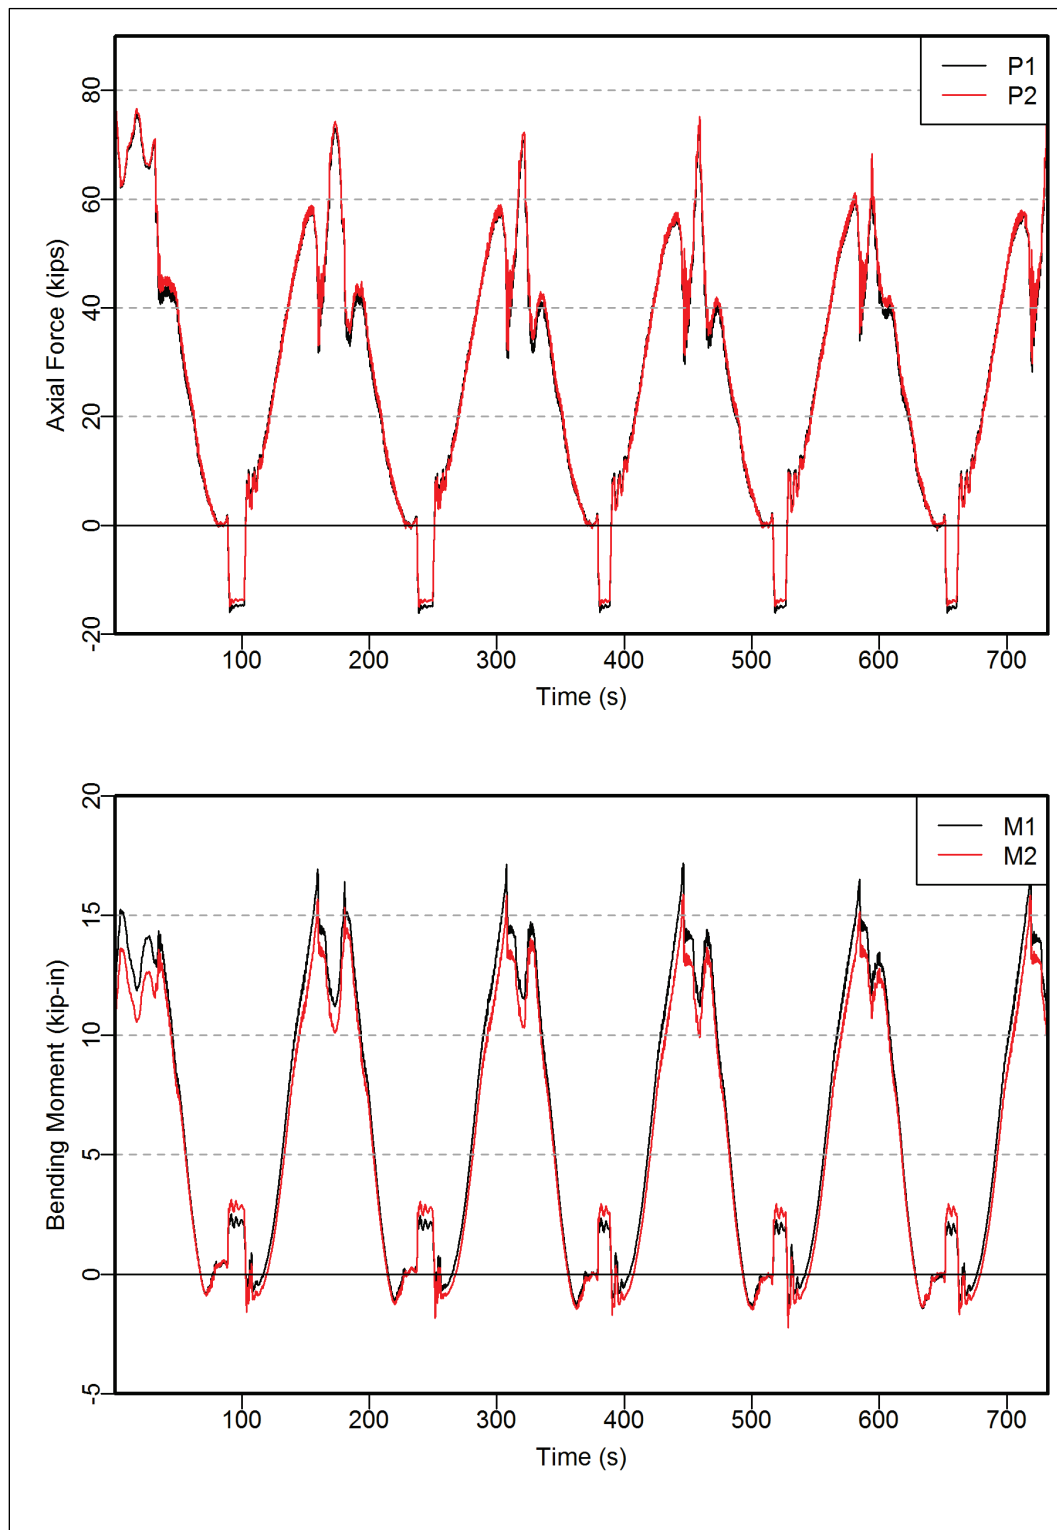
Figure 33. Computed forces in riverside miter rectangular segment – Set 3.
